1. REPORT NO. CA-TL-79-01		2. GOVERNMENT ACCESSION NO.		3. RECIPIENT'S CATALOG NO.	
4. TITLE AND SUBTITLE VEHICULAR IMPACT TEST ON STEEL CHANNEL-BEAMS SPANNING A GAP IN A CONTINUOUS CONCRETE MEDIAN BARRIER				5. REPORT DATE February 1979

STATE OF CALIFORNIA
DEPARTMENT OF TRANSPORTATION
DIVISION OF CONSTRUCTION
OFFICE OF TRANSPORTATION LABORATORY

VEHICULAR IMPACT TEST ON STEEL
CHANNEL BEAMS SPANNING A GAP IN A
CONTINUOUS CONCRETE MEDIAN BARRIER

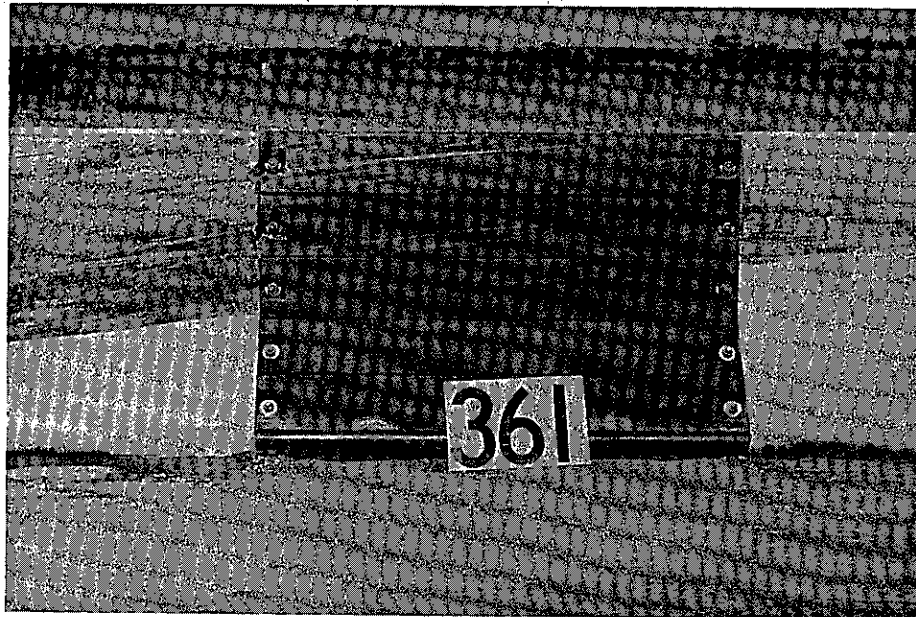
Figure 4 - Scuffs and Scrapes on Gap Beam

Gap Beam Performance and Damage - The gap beam sustained only minimal damage. The first three beams starting from the top of the barrier on the impact face were the only ones damaged. The top beam was bowed in permanently about 1/8 inch. The second beam was bowed in permanently about 1/4 inch. The third beam was not bowed. All three beams were scuffed and scraped as shown in Figure 4, but there was no apparent structural damage. The beams did not move in any other way. The two bottom beams were unmarked and showed no apparent damage of any kind. All beam and beam hanger connections showed no movement or failure of any kind.

The two top channel beams in the barrier bowed in slightly but it would not be necessary to replace them because the damage was so slight. Other than removing or painting over the scuff marks on the face of the gap beam, little maintenance would be required.

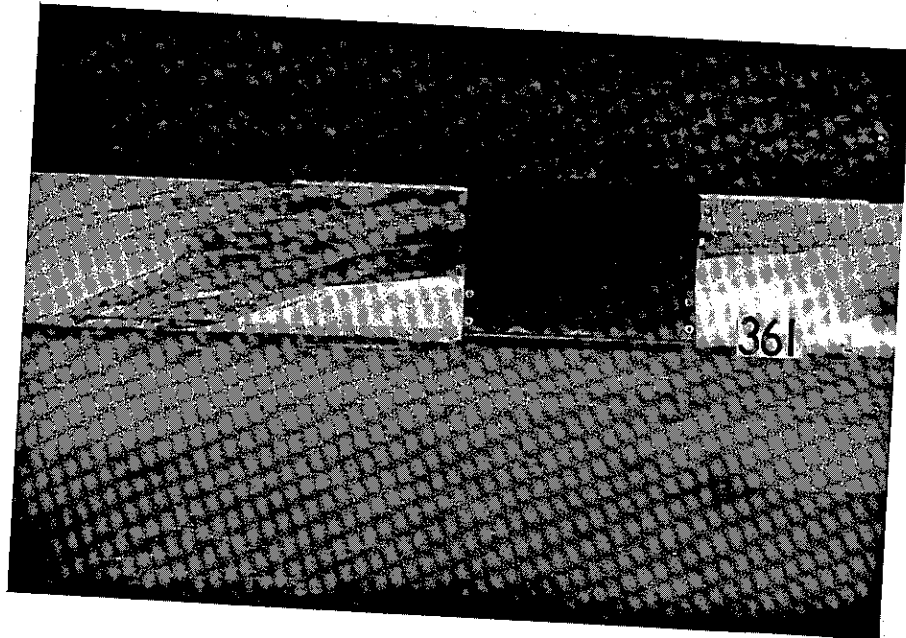
Figure 5 - Scuffs and Scrapes on Barrier

The barrier did not crack or sustain any structural damage during the test. Beginning at the point of impact the barrier was scuffed and scraped for about 14.5 feet as shown in Figure 5. There was some minor concrete spalling at the connection of the gap beams to the barrier, as shown in Figure 6. There was no change in the size of existing shrinkage cracks in the barrier.

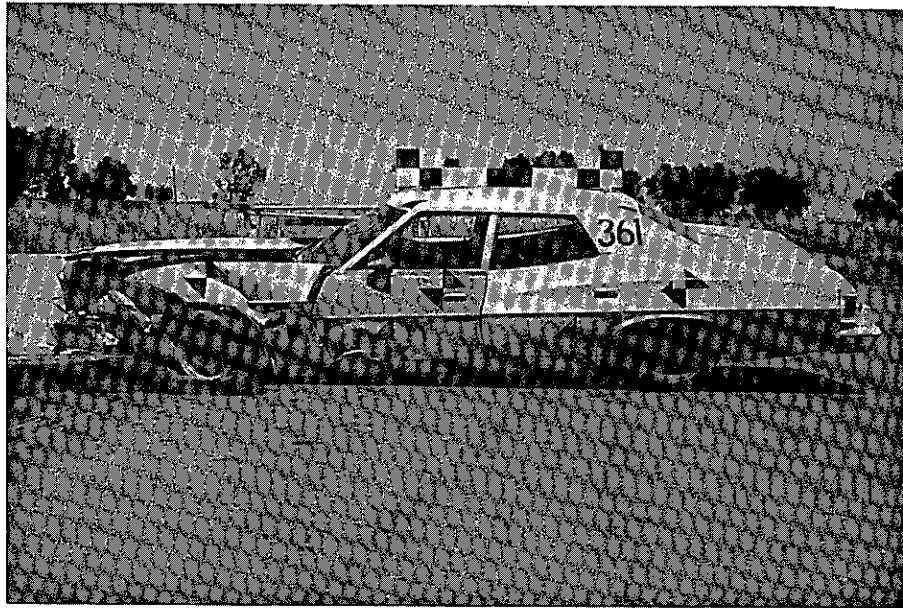
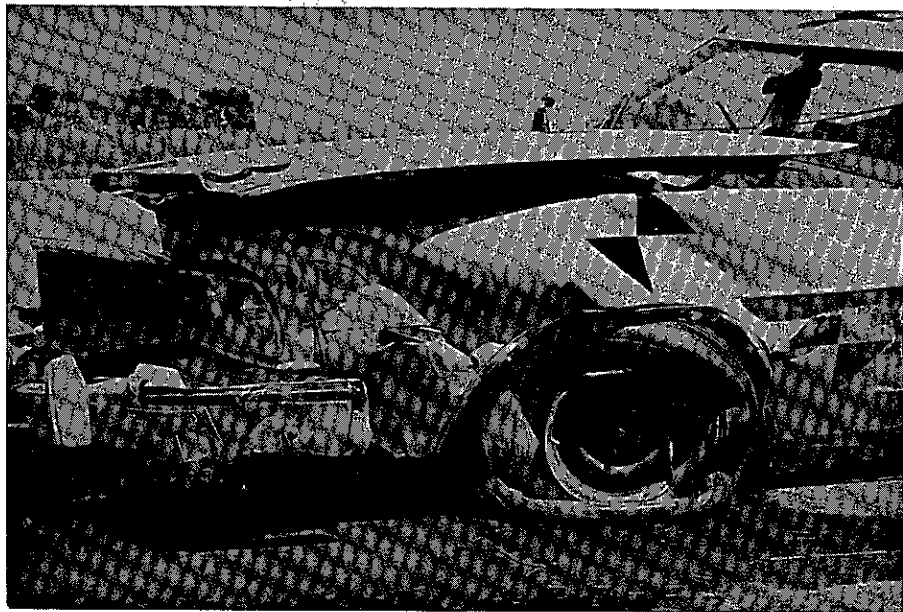
Figure 7 - Vehicle Damage

Vehicle Damage - The left front quarter panel and front bumper were crushed and pushed toward the right side of the vehicle as shown in Figures 7 and 8. The left side of the radiator was pushed back toward the fan and the windshield was cracked on the left side of the vehicle. The left front tire was flat and the rim was scraped and bent. The right front quarter panel was buckled above the tire.

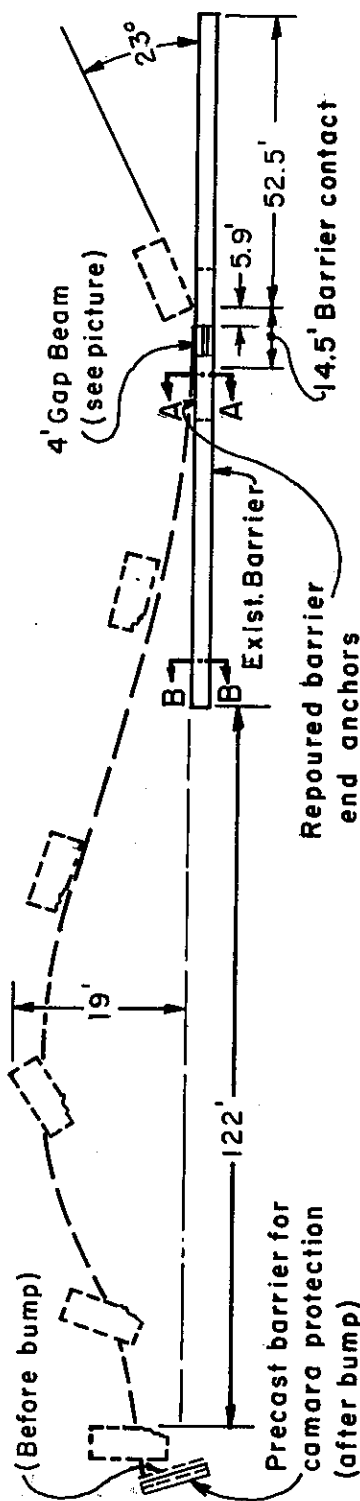
BARRIER.....CMB WITH GAP BEAM	TEST NO.....361
LENGTH OF BARRIER.....120 FT.	DATE.....8/16/78
MAX. PERMANENT LAT. DEFL. (SECOND BEAM FROM TOP).....0.25 IN.	VEHICLE.....1974 FORD GRAN TORINO
MAX. DYNAMIC LAT. DEFL.....0.50 IN.	VEHICLE WEIGHT.....4410 LBS. (WITH DUMMY & INSTRUMENTATION)
MAX. VEHICLE RISE/ROLL.....3.5 ft./22°	IMPACT SPEED.....61 MPH
LAT. K.E. = $(1/2)M(V \sin \phi)^2$84 FT.-KIPS	IMPACT ANGLE.....23°
VEHICLE DECELERATION (MAX. 50 MS AVG.)	VEHICLE DAMAGE: TAD LFQ-5, LD-3
LATERAL.....9.9 g's	VDI 10 LFQ-4
LONGITUDINAL.....4.4 g's	
VERTICAL.....4.6 g's

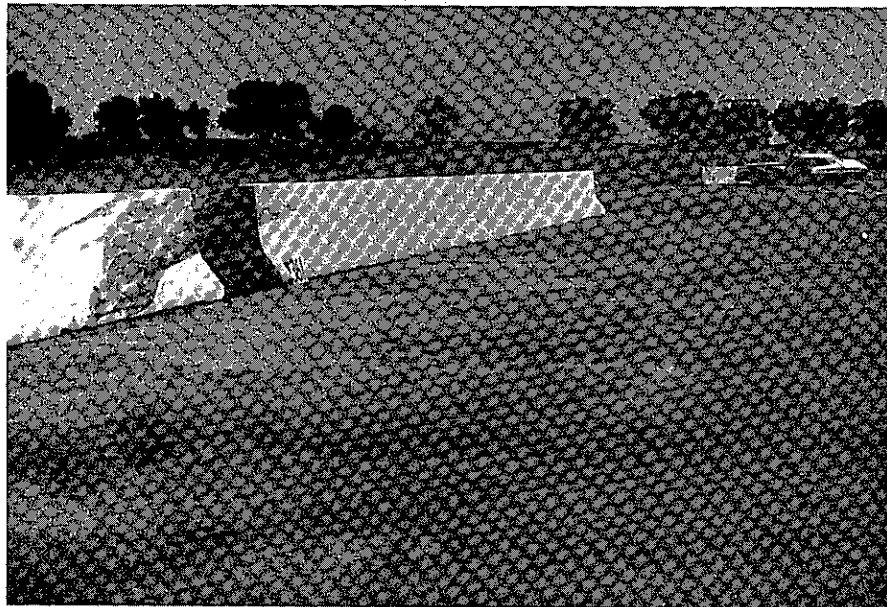
Figure 10 - Final Resting Position of Vehicle

The maximum rebound distance for the vehicle along its post-impact trajectory was about 19 feet from the impact side of the barrier. Assuming an 8 foot shoulder width next to the CMB and 12 foot traffic lanes, the test vehicle could have interfered with traffic in the lane closest to the barrier. The vehicle exited the barrier at about 7 degrees at a speed of about 50 mph. There was some flying debris from the vehicle but it probably would not have been hazardous to other vehicles due to its trajectory.

Other than the rebound of the vehicle, the post-impact trajectory was quite good, considering the severe conditions of impact. The vehicle did not roll over or spin out in an erratic manner, but coasted directly to a stop at a point along the line of the barrier, thus minimizing the amount of maneuvering that would have been necessary by following vehicles. The rear end of the vehicle at rest may have protruded into the closest traffic lane.
